CLOE DAM

NDI I.D. NO: PA-421

PHASE I INSPECTION REPORT  
NATIONAL DAM INSPECTION PROGRAM

JUNE 1979

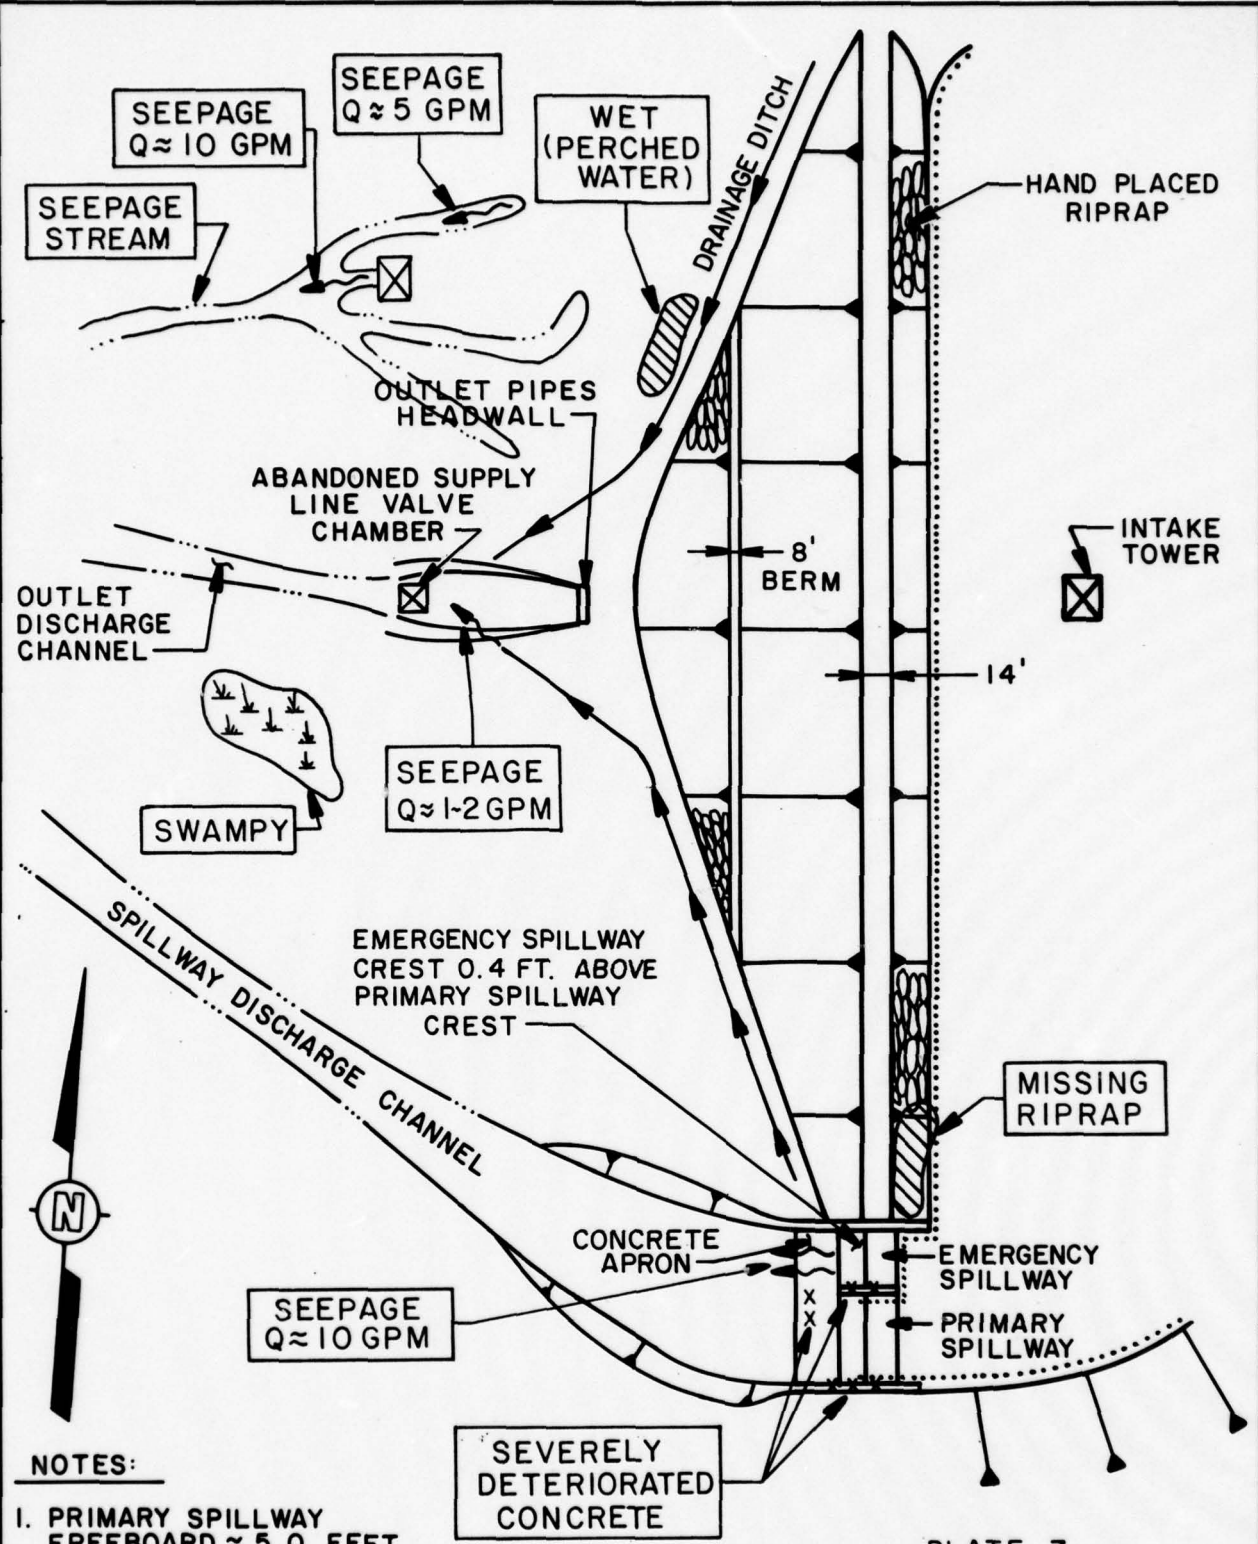
In general, the condition of the dam is considered to be good. Several seepage areas and one swampy area were found below the toe of the dam. One seepage area was located near the right abutment approximately 100 to 150 feet downstream from the toe of the dam. Flow from these seepage points was estimated to be in the range of 5 to 10 gallons per minute, respectively. Another seepage point, at the discharge channel of the outlet works, was flowing at approximately 1 to 2 gallons per minute. A swampy area was located approximately 150 feet downstream from the toe of the dam, to the left of the outlet works discharge channel. No flow appeared to be discharging from the swampy area. The downstream face of the dam was inspected and was found to be covered with well established grass in good condition. The riprap on the upstream face of the dam was also found to be in good condition, except for two locations. Near the left abutment and near the spillway approach channel, portions of the riprap apparently have been removed by vandals.

VISUAL EXAMINATION OF	OBSERVATIONS	REMARKS OR RECOMMENDATIONS
JUNCTION OF EMBANKMENT AND ABUTMENT, SPILLWAY AND DAM	No signs of distress.	
ANY NOTICEABLE SEEPAGE	One swampy and one seepage area below the toe of the dam. See Plate 7 for location and seepage flow estimates.	
STAFF GAGE AND RECORDER	None.	
DRAINS	None.

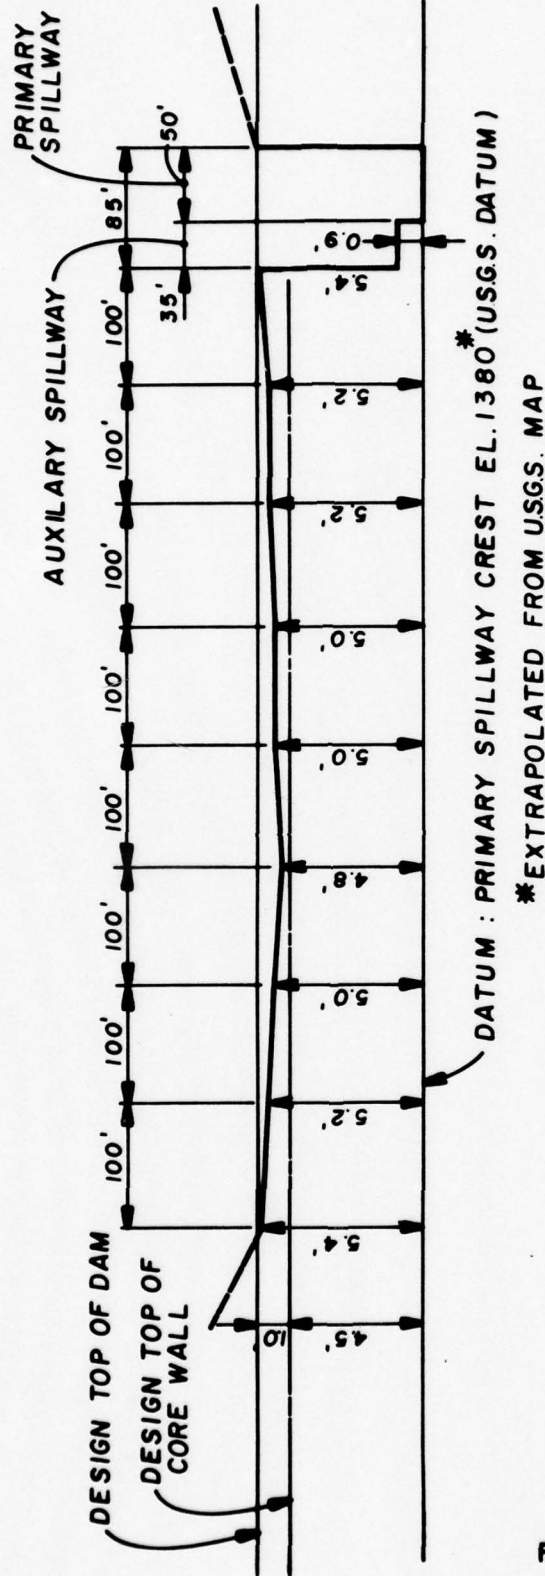
# **DAM CREST PROFILE** (LOOKING DOWNSTREAM)

The top of the dam was surveyed, relative to the spillway crest elevation, and was found to have some vertical irregularities. While the design freeboard of the dam was 5.5 feet, the survey indicated freeboards ranging from 4.8 to 5.2 feet. The lowest area occurred approximately at the center of the embankment. The dam crest profile is illustrated on Plate 8.

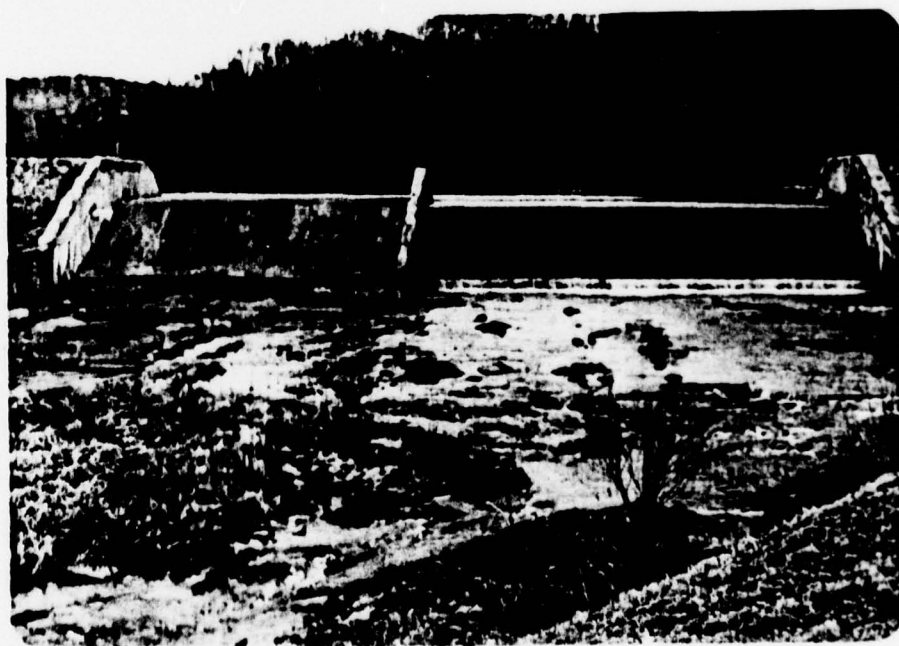
Photograph No. 2  
Primary spillway (right) and emergency spillway (left).

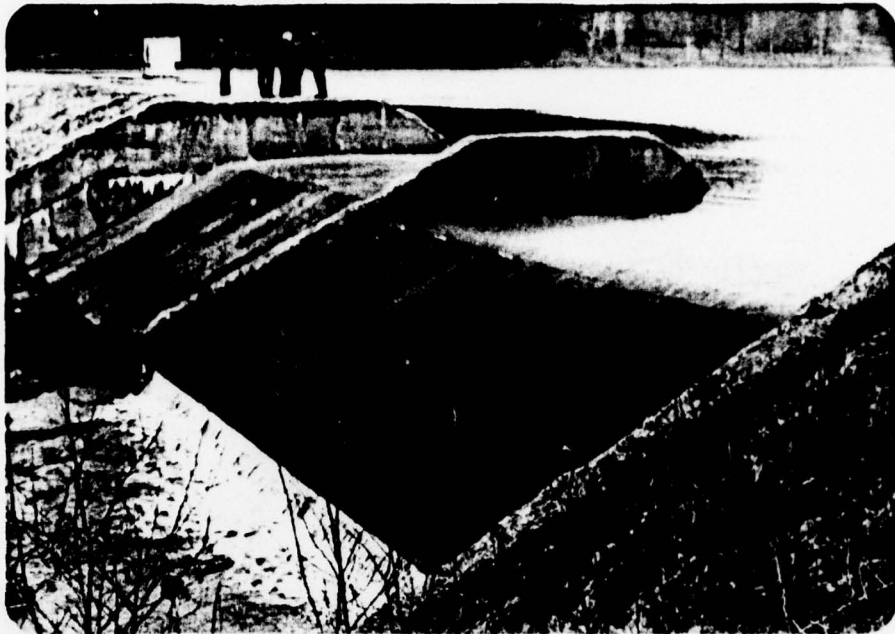
Photograph No. 3

c. Appurtenant Structures. The appurtenant structures were examined for deterioration or other signs of distress and obstructions that would limit flow. The spillway overflow structure was found to be in poor condition. The concrete was seriously spalled and cracked at various locations. Seepage was observed beneath the auxiliary side of the overflow structure. The condition of the structure suggests that major structural damage would be incurred in the event of large flows through the spillway. The visible portions of the outlet works structures were found to be in good condition. The downstream end of the outlet pipes was observed and no sign of distress was noted.

VISUAL EXAMINATION OF	OBSERVATIONS	REMARKS OR RECOMMENDATIONS
CONCRETE WEIR	The concrete in the spillway overflow structures has seriously deteriorated and cracked. There is seepage beneath the auxiliary spillway overflow structure.	Necessary repairs should be performed.
APPROACH CHANNEL	Submerged. Appears to be free of debris.	
DISCHARGE CHANNEL	Concrete is in poor condition.	Necessary repairs should be performed.
BRIDGE AND PIERS	None.

Spillways. Note deteriorating concrete.

2. The operational condition of the outlet works sluice gate should be evaluated and necessary maintenance performed.
3. Necessary remedial work should be performed on the spillway concrete structures to avoid further deterioration of concrete and structural damage.
4. Missing riprap on the upstream slope should be replaced.
5. The dam and appurtenant structures should be inspected regularly with the emphasis on seepage areas and necessary maintenance performed.

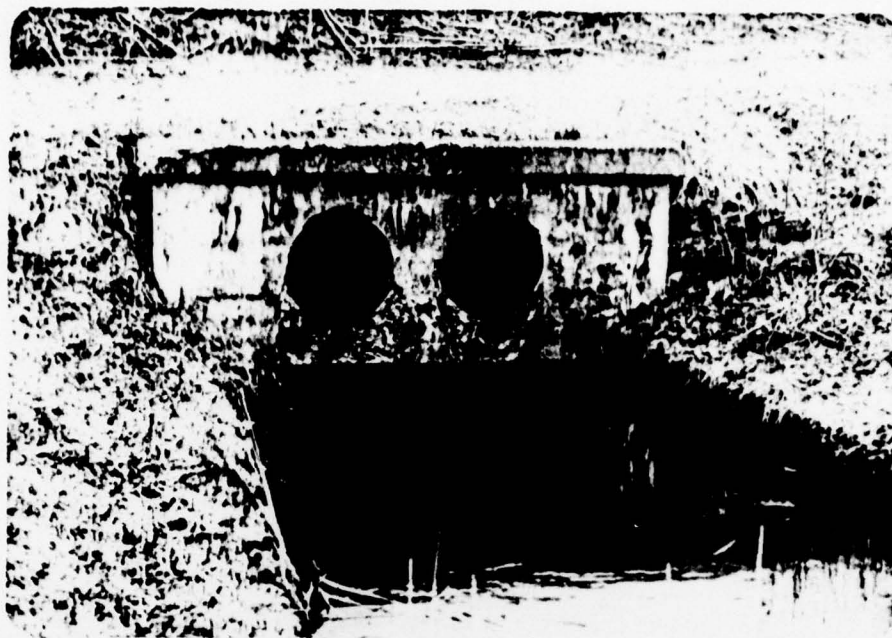
Photograph No. 5  
Outlet pipes.

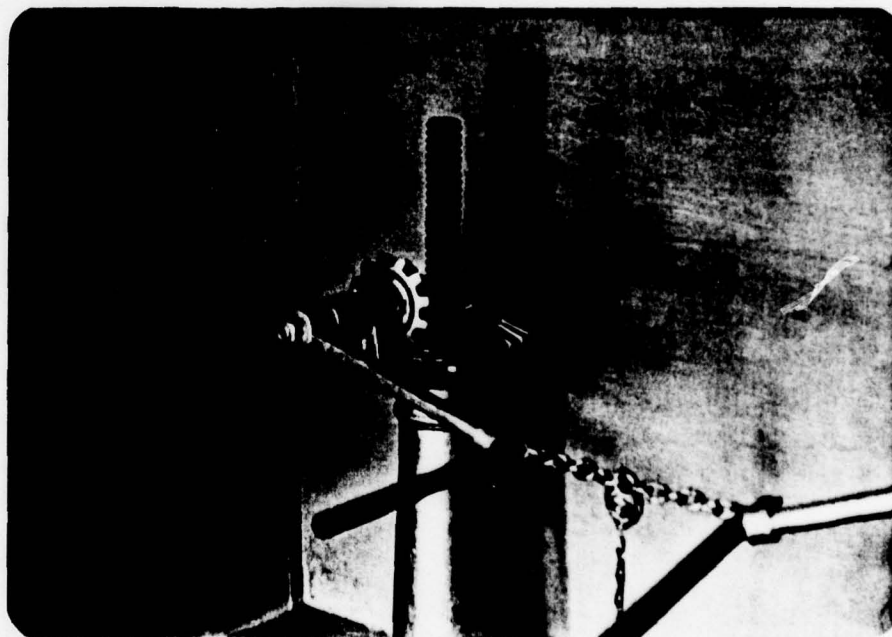
4.3 Maintenance of Operating Facilities. The maintenance condition of the operating facilities is considered to be good. However, Fish Commission personnel reported that the outlet conduit sluice gates have not been operated in the recent past. The operation of the sluice gates was not observed, because the operational condition of the gates was questionable.

Photograph No. 6  
outlet pipe controls at intake tower.

It is reported that the outlet pipe sluice gates have not been operated in the recent past. It is therefore recommended that the operational condition of the outlet pipe gates be evaluated and necessary maintenance performed.
